EVALUATION OF FOUR ACTIBUMPS AT CURTIN UNIVERSITY, PERTH, AUSTRALIA

In 2017 four active speed bumps, called Actibump, were installed at the Bentley campus of Curtin University in Perth, Australia. These active speed bumps were activated in late February of 2018. This report will detail and discuss the results so far.

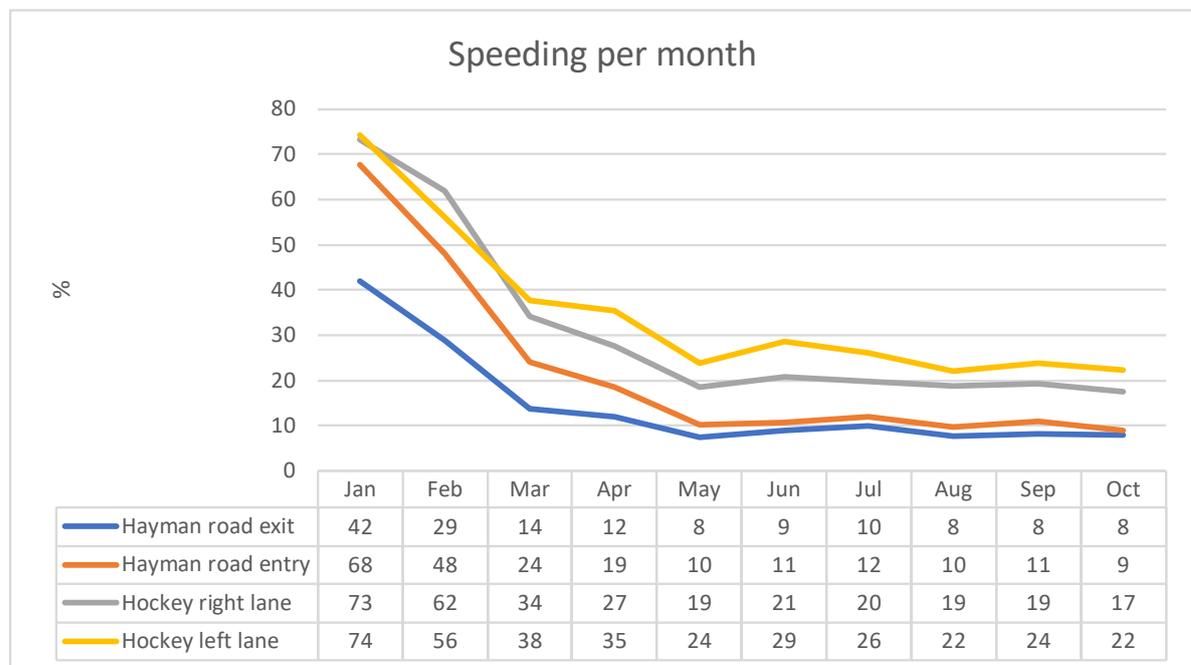
The speed limit is 40 km/h on all four Actibumps. On Dumas Road measurements showed as many as 74% of drivers were speeding. These numbers were decreased quickly after the activation of the four active speed bumps as can be seen in the diagram above.

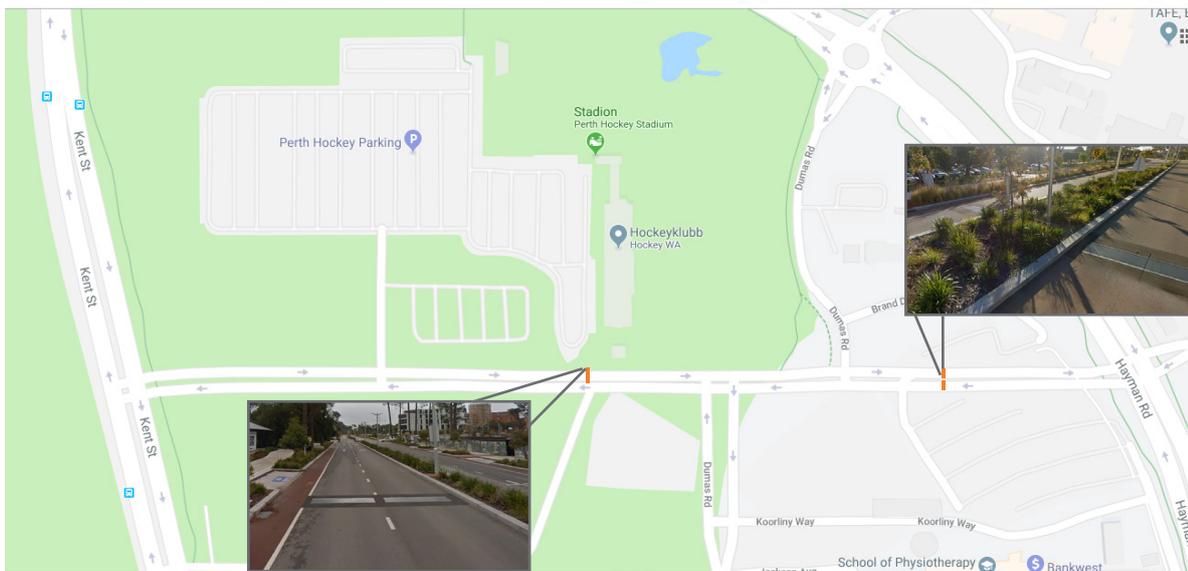
Left: Hockey left and right lane. Right: Hayman road exit and entry. Source: Google maps

All four Actibumps were installed on Dumas Road. Two side by side on a two-lane part of Dumas Road, near Perth Hockey parking. The oth-

er two were installed near Hayman road, one by the entry to Hayman road and one by the exit to Hayman road.

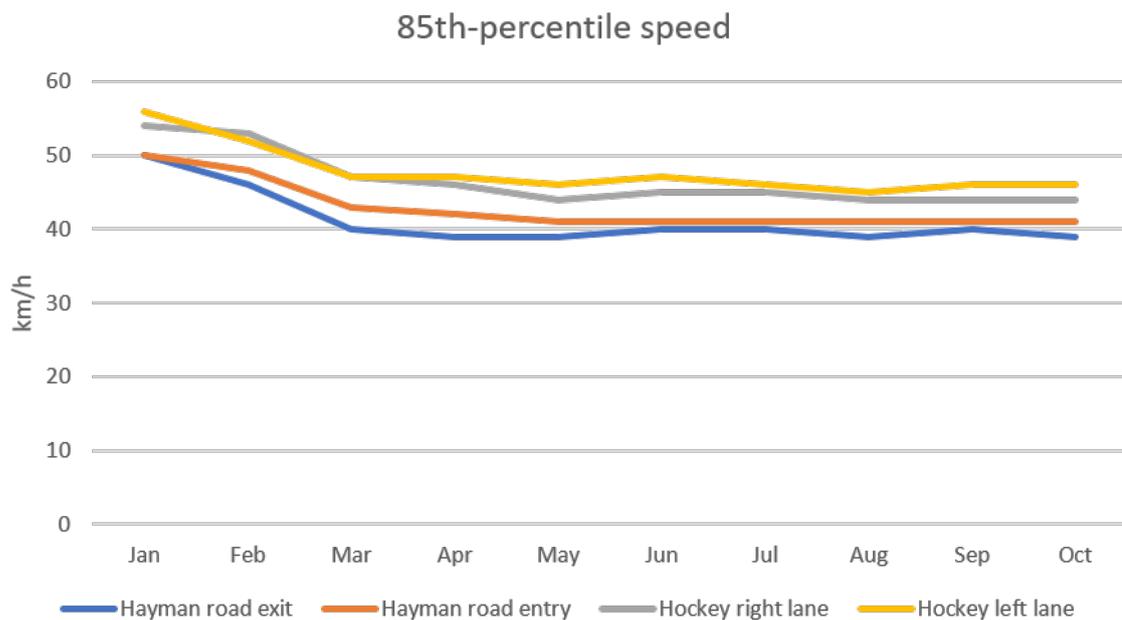
The effect of an Actibump tends to improve over time. After six months the large decrease after start has slowed down a bit but the results usually improve significantly over the first year of installation. After a year the results normally only improve a little. This is based on experience from Swedish installations where there is a lot of daily traffic. An interesting question is whether this is different since this is on a campus road where there will be an increase in new students every year.

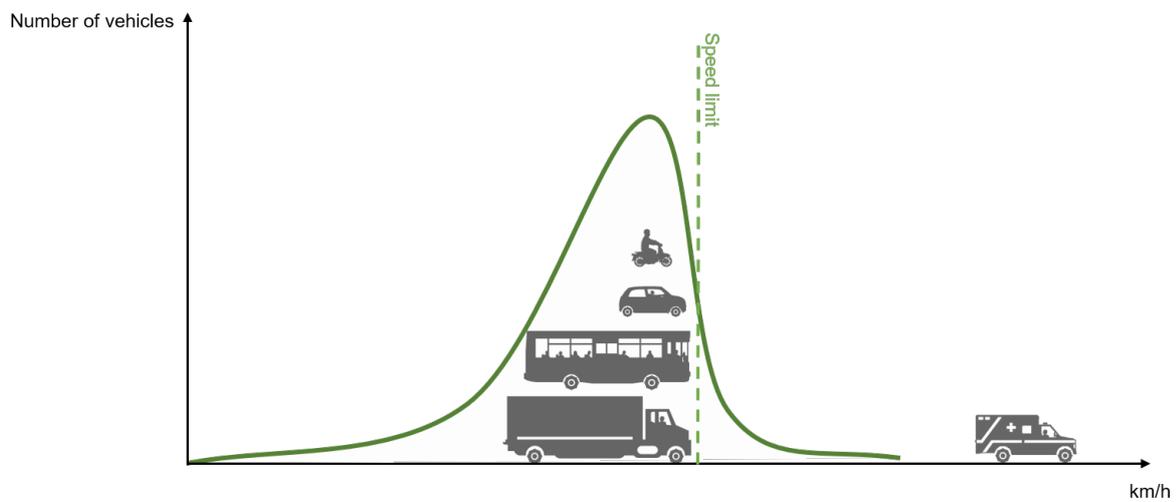
When it comes to traffic flow the image above shows the desired traffic flow: as many vehicles as possible driving at the same speed, on the

correct side of the speed limit. No vehicle type driving too slowly and only emergency vehicles driving above the speed limit.

On a road without any type of traffic calming measure the curve is normally spread out as a bell curve with a larger portion of the vehicles driving above the speed limit.

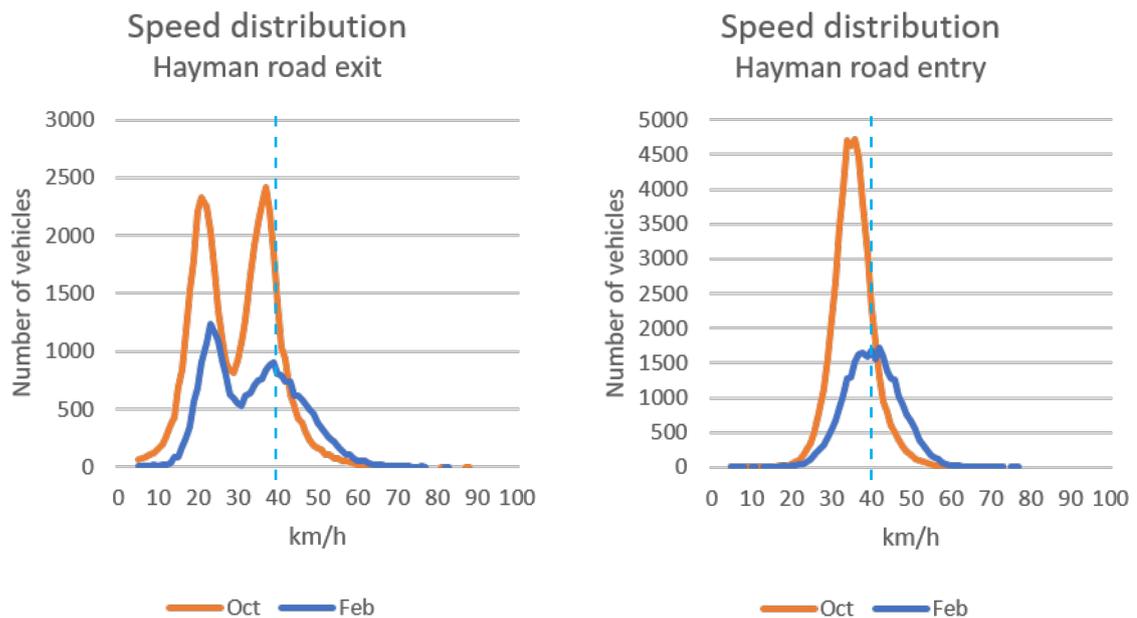
Above we have compared the month before the systems were activated with the month of October.

There are a few things to note about the speed distribution curves. The left one, Hayman road exit, is near a traffic light. The left tip of the curves is most likely caused by vehicles approaching a red light and therefore slowing down ahead of time.

On both left and right curves it can be noted that the orange line, October, is much high-

er than the blue line from February. This is of course because there were very few vehicles on campus during the summer break.

We can also see that the orange curve is more correctly placed next to the speed limit line. This is caused by the decrease of speeding. Notably nobody needs to slow down more than before on Hayman road entry and we can see the same driver behaviour on the left peak in February as well as in October.

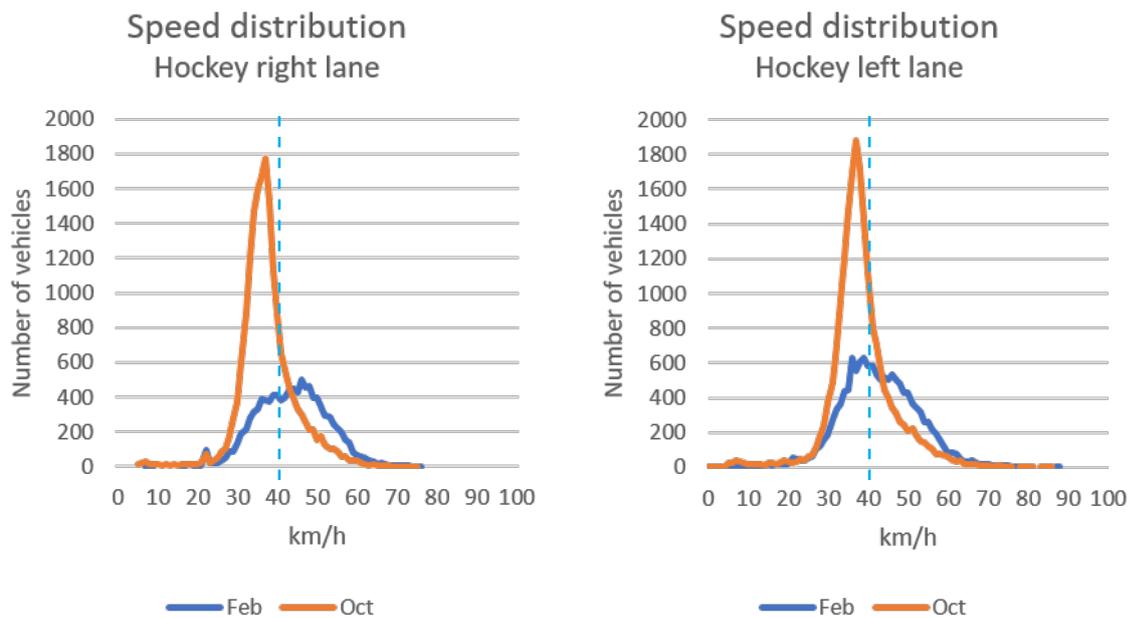
As can be expected, based on speeding and 85th-percentile there are more vehicles on the wrong side of the speed limit on the Hockey Actibumps than on the Hayman Actibumps but the blue curve is still closer to the speed limit than the orange curve so there has been an improvement.
